DEPARTMENT OF TRANSPORTATION

Contract #: 04-0120F4Cty: SF/ALA Rte: 80 PM: 13.2/13.9File #: 69.28**WELDING INSPECTION REPORT****Resident Engineer:** Siegenthaler, Peter**Address:** 333 Burma Road**City:** Oakland, CA 94607**Report No:** WIR-019540**Date Inspected:** 28-Jan-2011**Project Name:** SAS Superstructure**OSM Arrival Time:** 700**Prime Contractor:** American Bridge/Fluor Enterprises, a JV**OSM Departure Time:** 1900**Contractor:** Zhenhua Port Machinery Company, Ltd (ZPMC), Changxing Island **Location:** Shanghai, China**CWI Name:** Qiu Wen**CWI Present:** Yes No**Inspected CWI report:** Yes No N/A**Rod Oven in Use:** Yes No N/A**Electrode to specification:** Yes No N/A**Weld Procedures Followed:** Yes No N/A**Qualified Welders:** Yes No N/A**Verified Joint Fit-up:** Yes No N/A**Approved Drawings:** Yes No N/A**Approved WPS:** Yes No N/A**Delayed / Cancelled:** Yes No N/A**Bridge No:** 34-0006**Component:** OBG**Summary of Items Observed:**

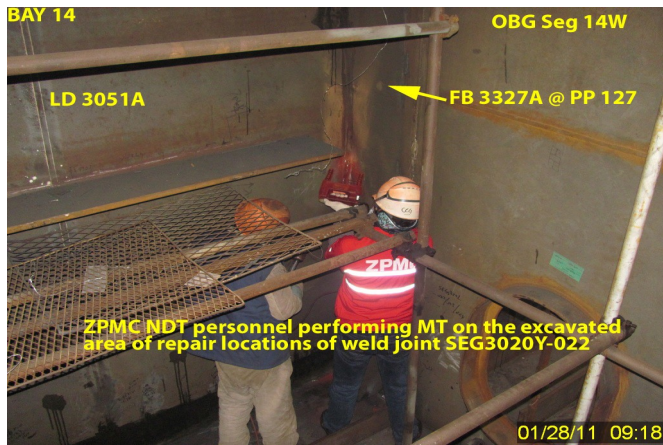
During random in process inspection this QA inspector observed that ZPMC NDT personnel performing Magnetic Particle Testing (MT) on the excavated area of repair locations of the weld joint SEG3020Y-022 joining Floor Beam (FB) 3327A to Longitudinal Diaphragm (LD) 3051A at Panel Point (PP) 127. Attached photograph provide additional details.
